Occasional Paper 128 – Brindley gates, safety gates, stop gates and stop planks

The Brindley Gate, (or Safety Gate):

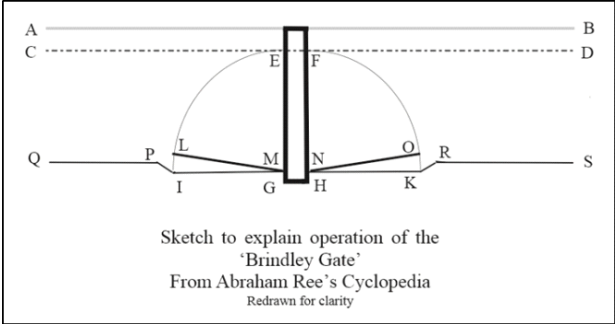
<p>Sketch to explain operation of the 'Brindley Gate' From Abraham Rees's Cyclopaedia Redrawn for clarity</p> <p>Fig 1</p>	AB	Represents the top of the wall, or height of the towing path under a bridge.
	CD	The surface of the water.
	QS	The bottom of the canal
	EFGH	Is a pair of hewn stones, or a piece of formed oak timber let into the wall, its face being flush therewith
	IEG & HFK	Are recesses about two inches deep in the wall; similar provision is made in the opposite wall, for receiving counterbalanced doors or gates LM and NO across the canal, turning on centres or hollow quoins at M and N.

Under normal conditions the counterbalanced gates LM and NO would be arranged to rest in the position shown on the sketch. In the event of a breach the increased flow should be sufficient to raise the gate facing the flow to the vertical position hence stopping the flow of water. The depressions at I and K across the bed beneath the gates are probably there to facilitate starting the initial movement of the gate. The back to back arrangement shown would allow strategically

As a breach occurs, flow velocity V_1 increases reducing the pressure over the gate. The restricted flow at V_2 below the gate induces a higher pressure thus creating an upward lifting force. The depression shown, as per Rees in Fig. 1, is there possibly to induce turbulence beneath the gate hence clear debris and assist the initial movement. (See comments in Appendix II, Test 6 and Conclusion.)

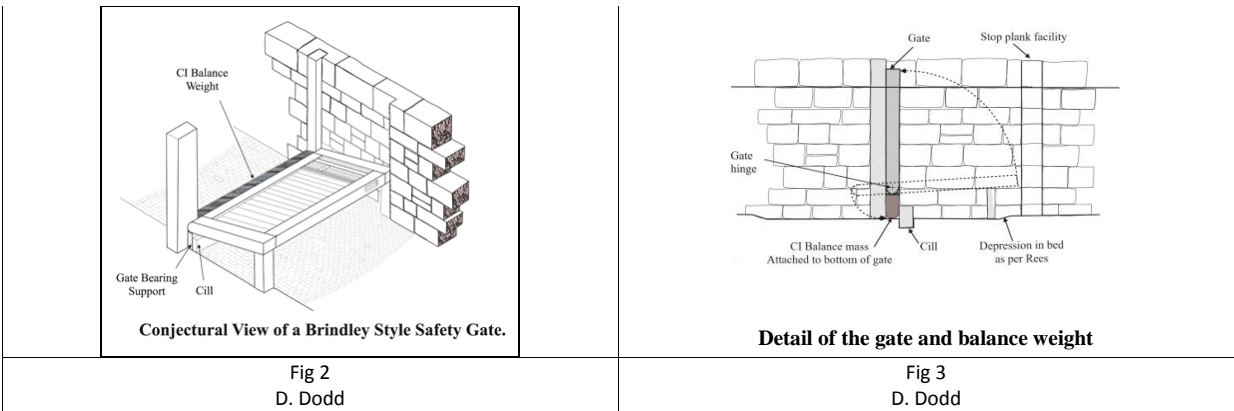
In order to meet these dynamic conditions it is necessary to design a gate to include the following features:

- The gate must include a counterbalance.
- The gate hinge must be above the canal bottom. (To allow for the counterbalance).
- The gate must seal off the water flow when closed.

Figs 2 and 3 show possible arrangements for the necessary features.

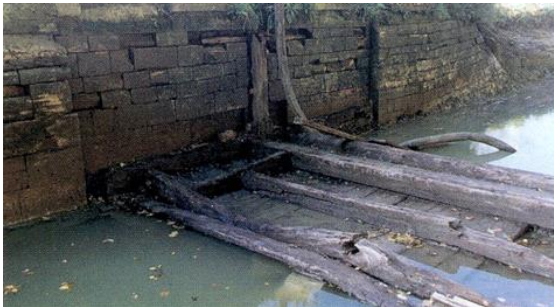
Plate 1
Limpley Stoke Stop Gate
from *Waterways World*, Feb 2001 P35

The gate shows no evidence of a counterbalance so was probably installed as a stop gate as were the ones on the Grand Western Canal. A block holding the gate clear of the canal bottom at a positive angle of about 5 degrees is evident under the centre, there to allow water to flow under the gate to assist when raising or lowering it, and to prevent silt from covering the assembly when in the open position. The gate is now on display at the Kennet and Avon Canal Museum, Devizes, Wiltshire

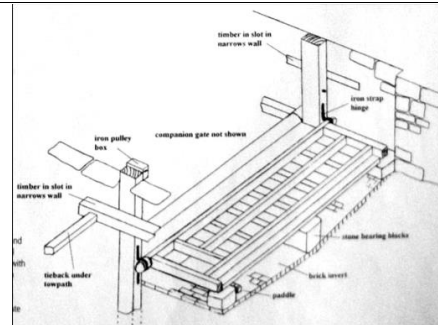
Fig 4.
Conjectural View of the Gate,
from *Narrow Boat*, Spring 2010 P.11

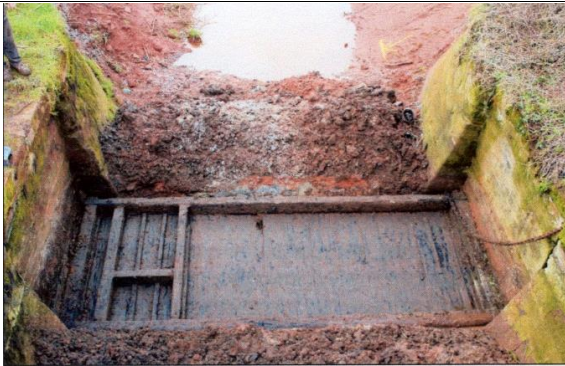
The upper surface of the sound gate was cleaned up and the construction details and other features recorded. A heavy chain was attached to the off side which presumably had been used for lifting the gate. Rather than the paddle arrangement described on the K&AC gates a type of hinged flap was used. It was difficult to fully assess the construction of the flap gear as a decision was made not to lift the gate but to leave it in its nearly horizontal position, resting on a short post which may have had the same purpose as the stone blocks at Limpley Stoke.

Plate 2,
Swing Bridge viewed from East.
Shows post projecting through the gate. AC Archaeology

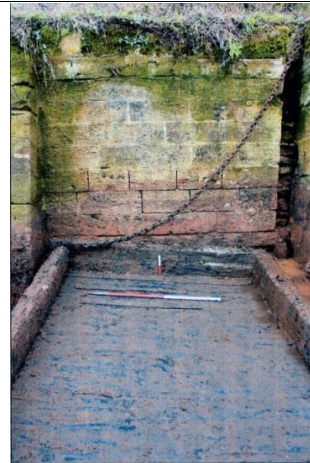
Plate 3,
Swing Bridge viewed from the South
showing recess in North abutment. AC Archaeology

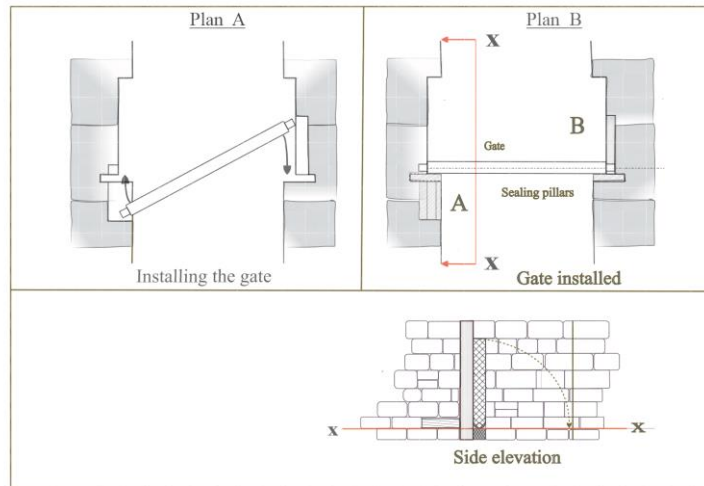
Fig 5
Conjectural view of Limpley Stoke arrangement. D. Dodd

Fig 5 indicates that the gates could just as easily be installed with the slots A and B on the same side of the gate with A opposite to B. It would also make for a cheaper construction and evidence of this arrangement was seen at Rock Bridge during the repair work. See Plates 4, 5, 6 & 7.

The *Narrow Boat* article of Spring 2010 mentions two slots, one in each side wall and facing in opposite directions, adjacent to the vertical timber gate jamb. It was concluded that their function was to facilitate installation of the gate by lowering it in askew and twisting it into the working position. It is assumed that the gate was then secured by inserting wooden wedges into the slots.

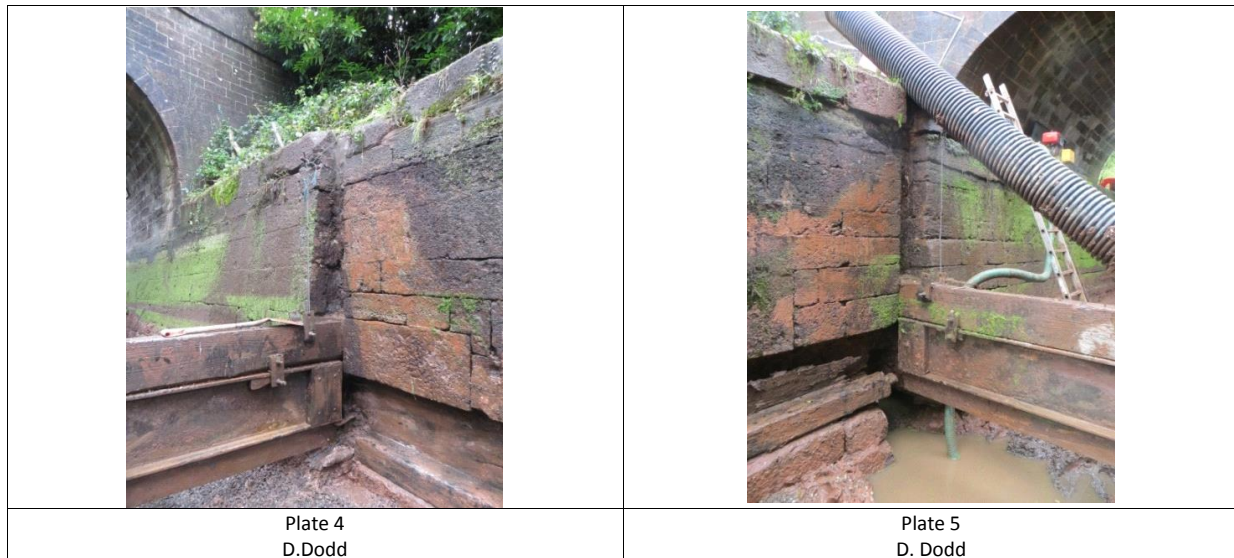
Plates 4 and 5 of the Rock bridge site show how the gate jamb grooves have been utilised as a stop plank facility and a steel beam inserted as a cill and a stop plank in position above it. The wedge slots are clearly visible and suggest that the arrangement was simplified as described above as they are opposite each other..

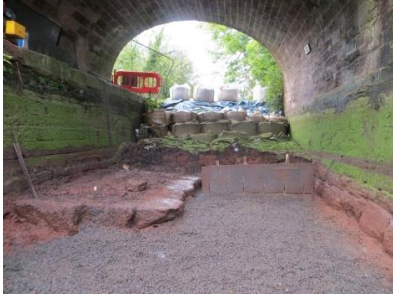
Plate 6
D. Dodd

Plate 6 shows damage to the original bridge stone invert and Plate 7 shows a mason's mark at Rock Bridge.

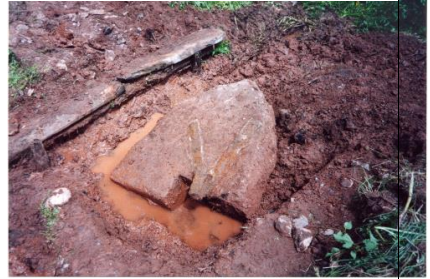
Plate 10
D. Dodd

along the tub boat section of the Grand Western Canal near Cothay Manor in Somerset, known locally as Jay's Cutting. To the east there are 300 m of canal embankment where the canal is infilled. The Tithe Map showed a restriction in the canal at the feature change and the WRG were instructed to use their plant judiciously and hand dig where appropriate. Flat stones at ground level provided a path over the canal line but beneath them was a grid of stones and timber set to fill in the depression: Plates 8, 9, and 10. Some of the stones were fashioned to provide a typical lock arrangement including stop plank grooves and gate hinge features. Finally, the base was exposed showing various grooves for timber components and the remains of a vertically hinged gate lying at about 45 degrees across the canal bed: Plate 11. Working conditions were difficult because of continued ingress of water.

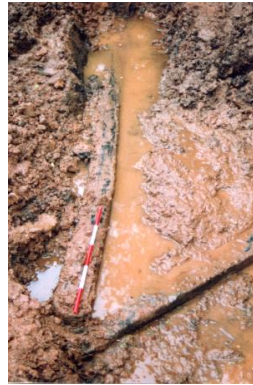
Plate 12
D. Dodd

The gate hinge was on the south side of the chamber, Plate 13 and a recess in the wall accommodated it when open, Plate 12. The north side vertical wall was curved, Plate 14, to accommodate the gate as it swung into the closed position. The stop plank grooves were on the downstream side of the gate.

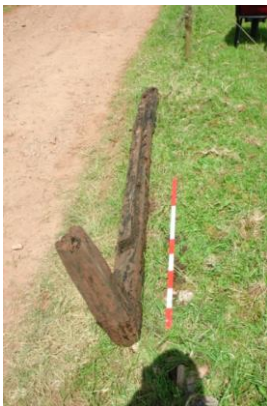
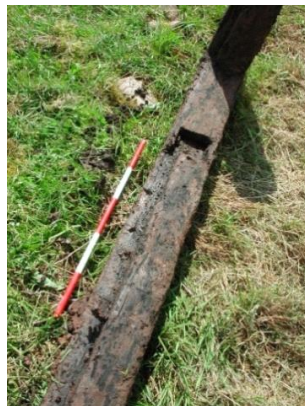
Plates 15 and 16 show all that remained of the gate after removal. Plates 17, 18, 19, 20 and 21 show the excavated stones.

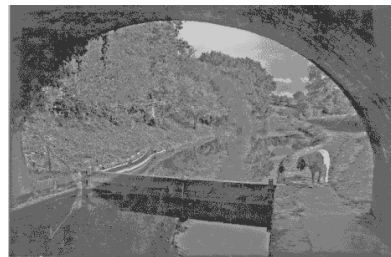
Plate 22
Baker Gr07.E01.S01.P01

Stop planks are simple, and their simplicity makes them reliable. They consist of vertical slots cut into the masonry walls either side of a canal into which wooden planks are lowered to form a dam to isolate a section. They are invariably installed at a canal narrowing at either end of embankments, locks, inclined planes, lifts, bridge holes etc. – anywhere where the engineer would deem them to be useful for maintenance purposes. Plate 22 shows a typical siting under a bridge where masonry walls are necessary anyway. The canal beyond the stop planks has been drained.

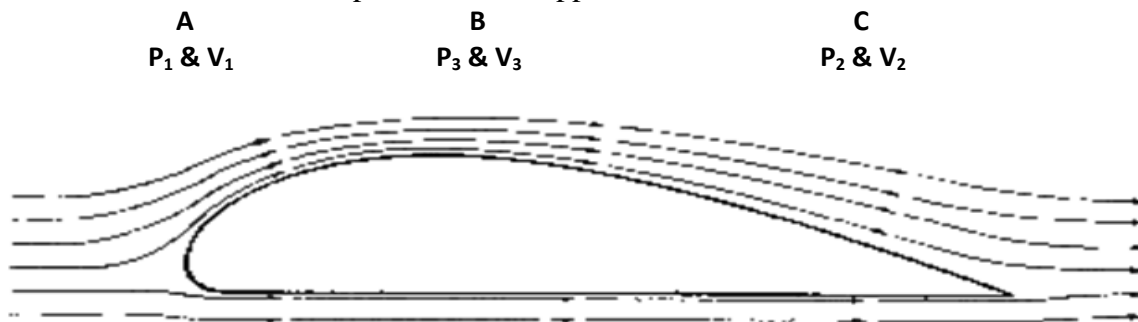
Consider Figure 7. This represents streamline flow over an hydrofoil showing how the streamlines close in over the top of the of the upper surface.

Figure 7 – Streamline flow over an hydrofoil

At positions A & C **$P_1 \& V_1$** & **$P_2 \& V_2$** have the same values.

But at **B** the closing in of the streamlines constricts the flow. As a result there is an increase in **velocity** over the top of the hydrofoil resulting in a **low-pressure** area. This, being lower than the pressure beneath the hydrofoil, creates a lift.

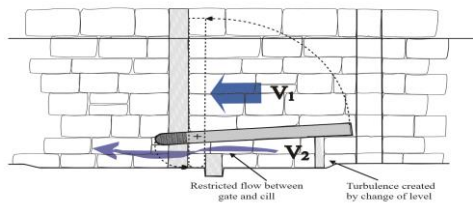
Fig 8 Gate open
D. Dodd

Fig 8 Gate open:

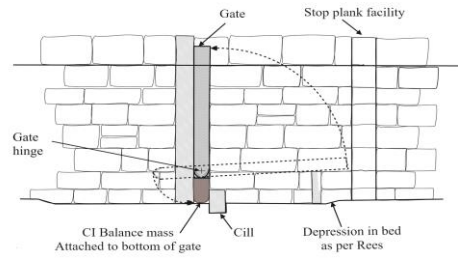
Fig 9 Gate shut
D. Dodd

Fig 9 Gate shut:

Velocity V_2 decreases as the gate closes

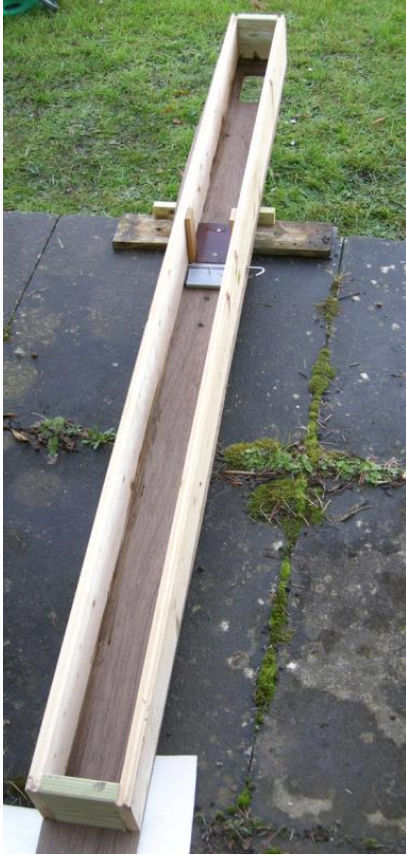
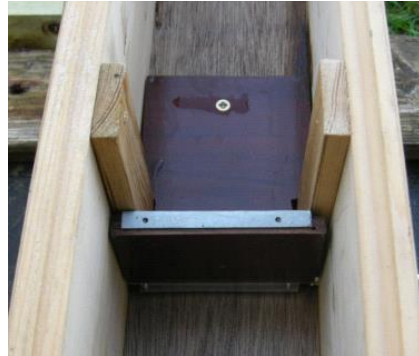
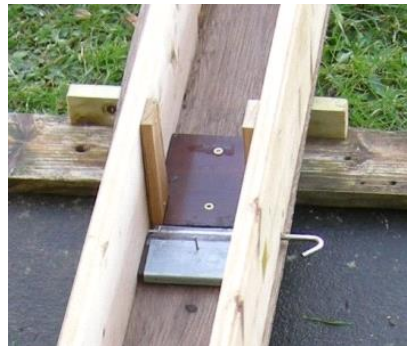
Views of the Test Rig
John Ditchfield

- Trough width-----90mm
- Gate weighted with a piece of sheet metal to prevent buoyancy
- Hinges A piece of slender rod passing through two eyelets.
- Photos taken from the upstream side.

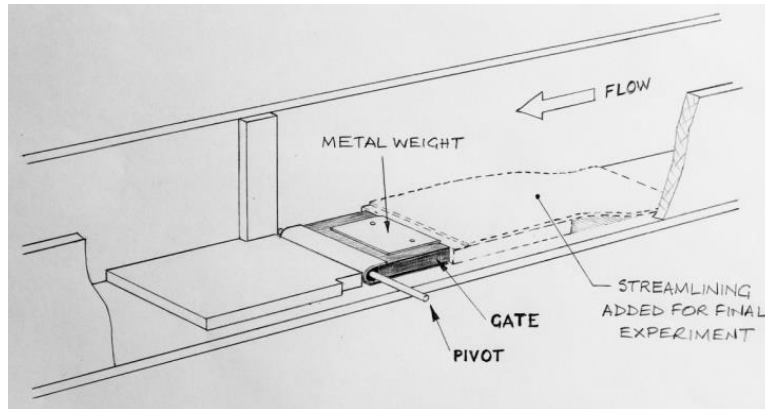
Fig 10 Test Rig Schematic
John Ditchfield

<p>1st Test</p> <p>A piece of wood the same thickness as gate placed on the floor of the canal, upstream and close to the edge of the recumbent gate.</p> <ul style="list-style-type: none"> • Canal filled, drain hole uncovered • The gate stayed put. 	
<p>2nd Test</p> <ul style="list-style-type: none"> • Piece of floor wood removed. Front edge of gate propped up by about 5 mm. Canal drained • <i>Gate lifted as water flow developed, and closed rapidly.</i> 	
<p>Piece of floor wood moved from upstream to downstream (as seen in photos), and hinge modified to minimise leakage under gate.</p>	
<p>3rd Test</p> <ul style="list-style-type: none"> • Gate propped at front by a smaller amount - about 3mm. • <i>Water released, gate worked.</i> 	
<p>4th Test</p> <ul style="list-style-type: none"> • Gap under front edge of gate reduced from 3 to 1.2 mm. • <i>Still worked OK.</i>
